02/02/2016

## Slow Drains are impacting your SAN!

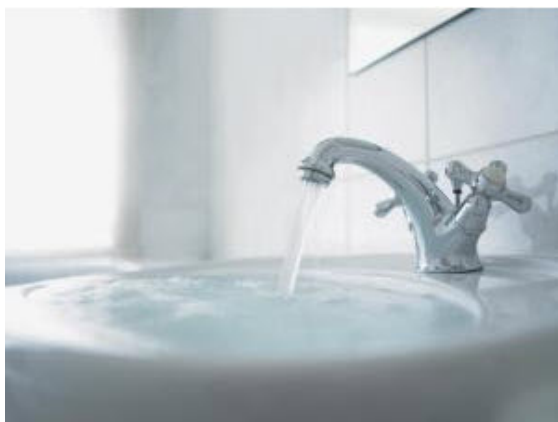
For example, let’s assume that we have a pipe that is capable of transporting 16Gps (Gallons per second) but an outlet that only allows 8Gps. As long as the amount of water flowing through the pipe is less than or equal to 8Gps, the water will flow out of the pipe at approximately the same rate as it flows into it. As you would probably expect, since there is 16Gps of capacity in the pipe, the rate at which water flows into the pipe could exceed 8Gps for short periods of time and the pipe could act as a kind of buffer. You would also probably expect that if you were to consistently exceed an average of 8Gps, you would quickly notice the water level in the pipe starting to rise.

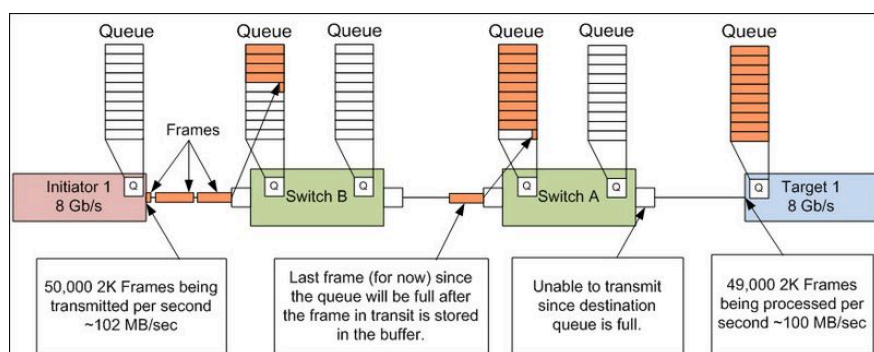
It's important to note that in all of the above scenarios, [Buffer-to-Buffer flow control](#) is used to ensure that there is sufficient buffering available on the receiver to store all frames put onto the wire by the transmitter. As a result, the transmitter experiences congestion whenever it is unable to transmit a frame due to a lack of buffer at the other end of the link. For example, as shown below, congestion has spread from the Target back towards the Initiator due to a mismatch in data rates.

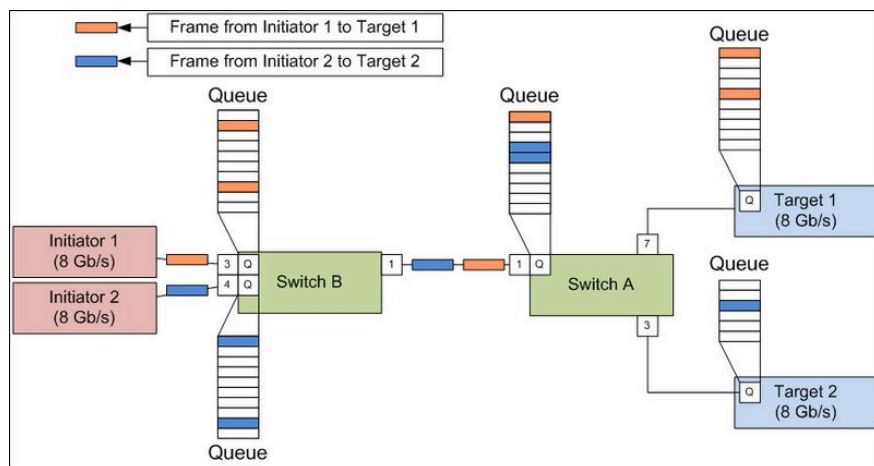
The impact that the problem being shown above will have on the rest of the fabric might not be obvious at first glance but let's see what happens with a slightly more complicated topology. I'll start by adding another Initiator and Target pair (e.g., Initiator 2 and Target 2). Note that the receive queue on switch A contains 3 frames, one for Target 1 and two for Target 2. Since there is ample space in the receive queue on switch A, the Initiators attached to Switch B are probably not experiencing congestion very often.

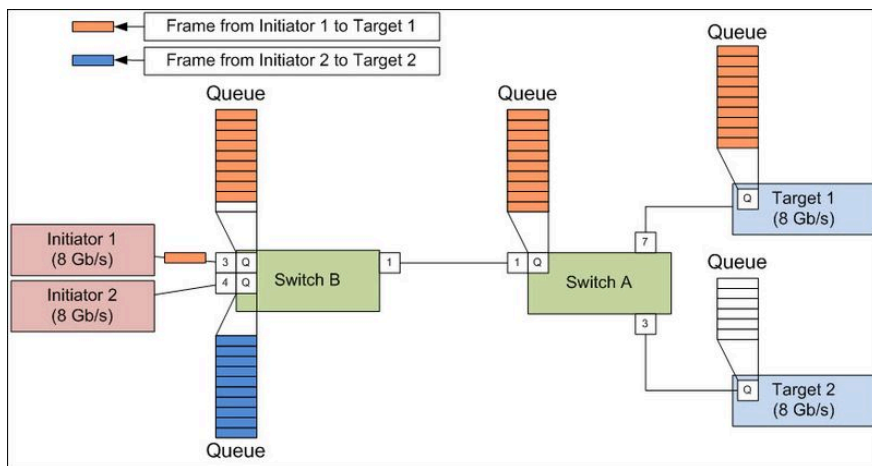
However, if I slow down the rate at which Target 1 is pulling frames from its queue, you notice that something very interesting happens as shown below.

Note that Target 1 appears to be receiving frames at a rate faster than it can process them and as a result its local queue is filled. This in turn causes the receive queue on switch A to fill with frames destined to Target 1 since the frames destined to Target 2 are transmitted soon after they are received. In extreme cases, such as the one shown above, this congestion can spread all the way back to the Initiators and prevent them from transmitting frames. When things get to this point we typically see two basic scenarios:

1. Target 1 is truly stuck and not releasing ANY credits. In this situation, this condition can persist for up to 2 seconds at which point the switch will initiate the Link Reset protocol.
2. Target 1 is not completely stuck, and as illustrated in the first diagram, is instead only capable of processing frames at a rate which is slower than the rate at which they are arriving. In this case, the impact to the rest of the environment can be both significant and long lived, at least until the condition is detected and resolved.

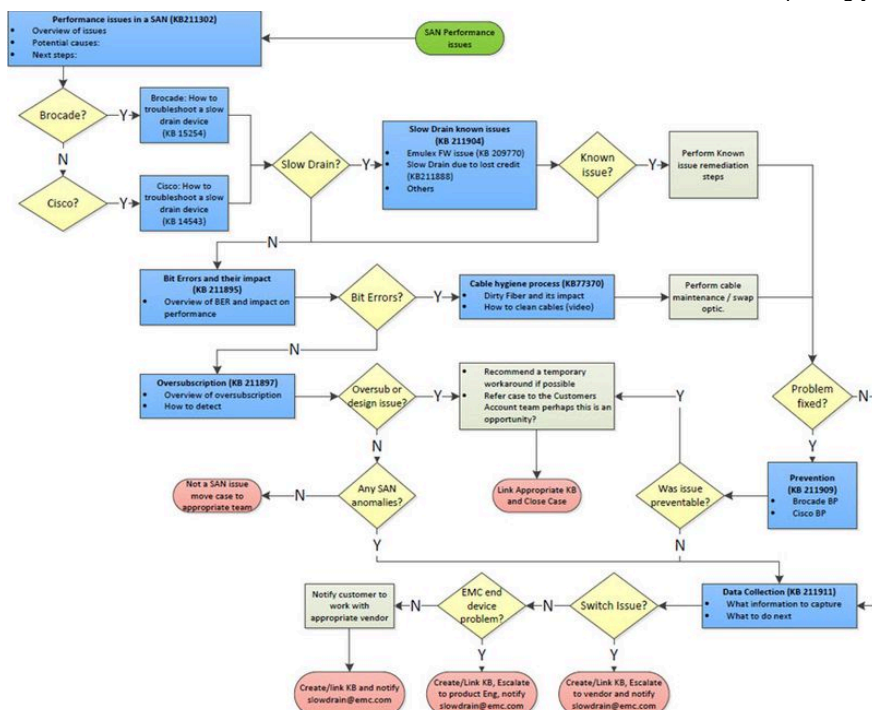
While the above scenarios may seem a bit extreme, they can and do happen in our customer's environments. As you can imagine, when these events occur they can be very painful because they have such a wide impact and can be somewhat hard to troubleshoot. In addition, the reason that a particular end-device (both Initiators and Targets) act as a slow drain is not very well understood at this point in time. As a result, we decided to come up with a process to help identify, troubleshoot, resolve and prevent slow drain devices; an overview this process can be found in [EMC KB 464027](https://brassstacksblog.typepad.com/brass-tacks/2016/02/slow-drains-are-impacting-your-san.html) and is shown below for reference.

Our hope is that our customers will use this process to help them detect the presence of potential slow drain devices before they become a significant problem and impact their environments. There's also a ton of background information and links to deep dives on the different concepts involved in case you need it.
